Heavy Duty
Gate Valve
7500 PSI

Demco® Style 2" 7500 psi Gate Valve (REDUCED PORT)

Complete 4" 7500 PSI Valve

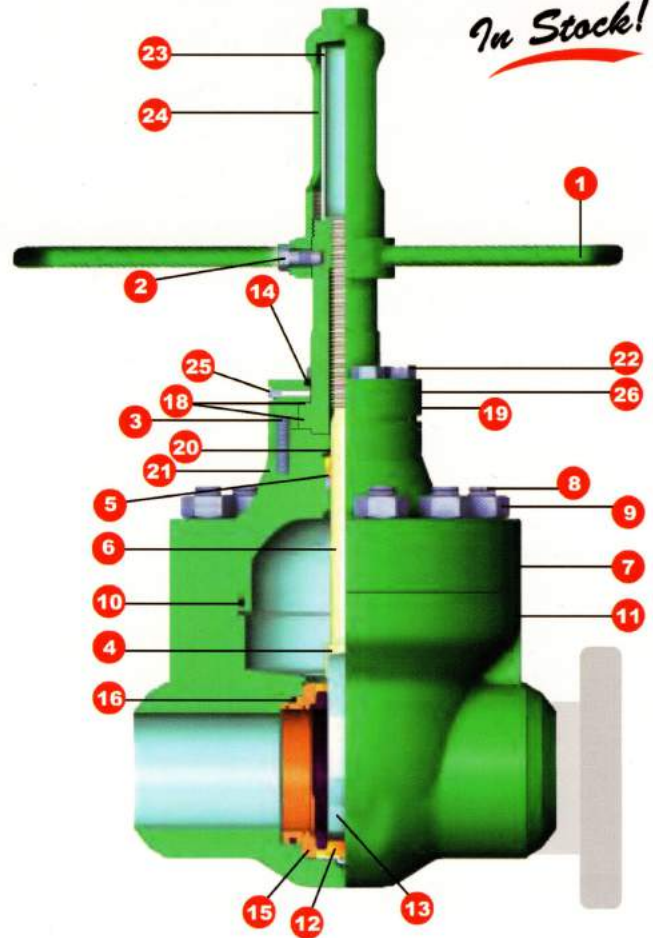
PART #	DESCRIPTION	QTY	
1	DGV - J015334	Handwheel	1
2	DGV - J014832	Handwheel Screw	1
3	DGV - J005666-32028	Retainer Screw	4
4	DGV - M450505	Gate Clip	1
5	DGV - J015853-008	Stem Seal Assembly	1
	DGV - J015853-006	(with bronze Bushing)	
6	DGV - 2140684-01	Stem	1
7	DGV - 2172523-02	Bonnet	1
8	DGV - 2171978-11-01	Body Stud	10
9	DGV - J053252-140	Body Stud Nut	10
10	DGV - 2712426-11	Bonnet Seal	1
11	DGV - 4-7500-BW	Body Option: Flanged	1
12	DGV - 2139746-01	Seat	1
13	DGV - 2171267-01	Gate	1
14	DGV - J005526-228	Housing Seal	1
15	DGV - M452290	Body Wear Ring	2
16	DGV - 2712787-04	Wear Ring Seal	2
18	DGV - J0023888	Stem Screw with Bearings	1
19	DGV - J015332	Housing	1
20	DGV - 2726268-01	Secondary Seal	1
21	DGV - 2172425-02	Packing Retainer	1
22	DGV - 702500-14-00-34	Housing Strew	4
23	DGV - J012852	Stem Tube	1
24	DGV - J015855	Stem Cap	1
25	DGV - J005195	Lube Fitting	1
26	DGV - J051971	Relief Fitting	1
